TEST REPORT

No. : XMIN2103002767CM

Sample Name : FIRE RATED DOWNLIGHT

To determine the fire resistance of a timber floor assembly protected by a plasterboard ceiling designed to provide 30 minutes fire resistance, incorporating 14 Fire rated Downlight fittings, when tested in accordance with Clause 7 of BS 476-21:1987 "Fire tests on building materials and structures – Part 21: Methods for determination of the fire resistance of loadbearing elements of construction".

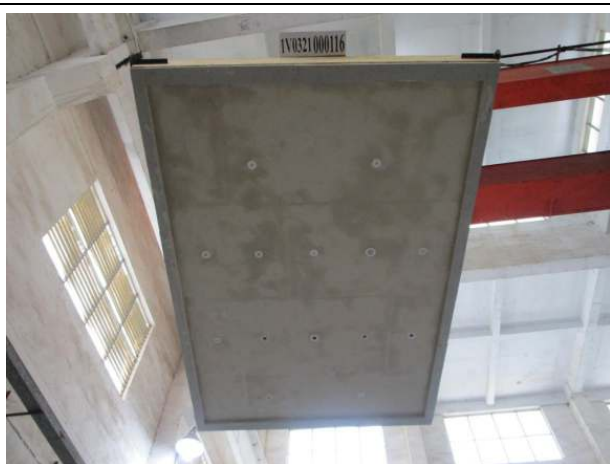
Photo 29: The exposed surface of the specimen before the test

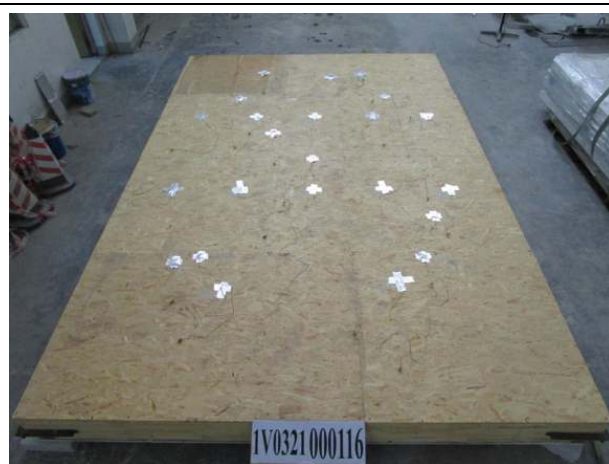
Photo 30: The unexposed surface of the specimen before the test.

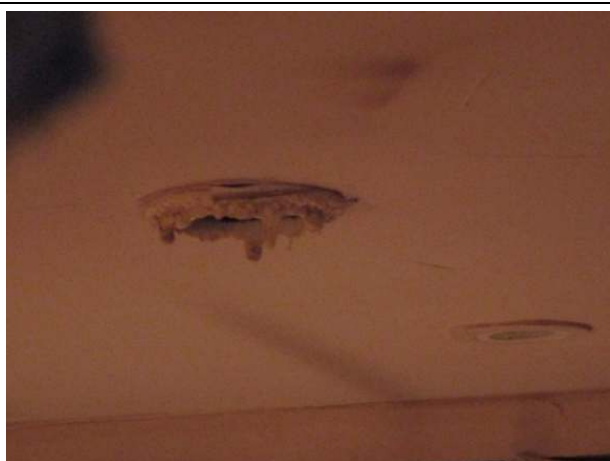
Photo 31: The exposed surface of the specimen after test duration of 3 minutes, showing the bezel of specimen 'D' fused.

Time (min)	Observation (All observations are from the exposed face unless noted otherwise)
0	Test started.
3	The bezel of specimen 'D' started to fuse.
5	Some lens of specimen fused.
11	Coating of the plasterboard ceiling fell away.
24	The first layer plasterboard ceiling started to sag slightly and joints began to open.
30	Part of first layer plasterboard ceiling fell into the furnace.
31	Test terminated at sponsor's request.

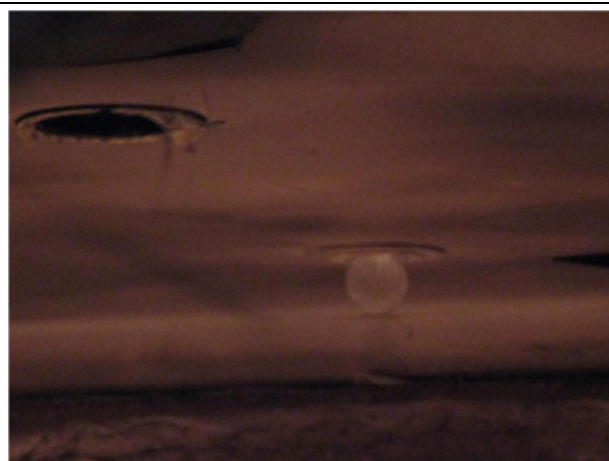
Photo 32: The exposed surface of the specimen after test duration of 5 minutes, showing the lens of specimen 'E' fell away.

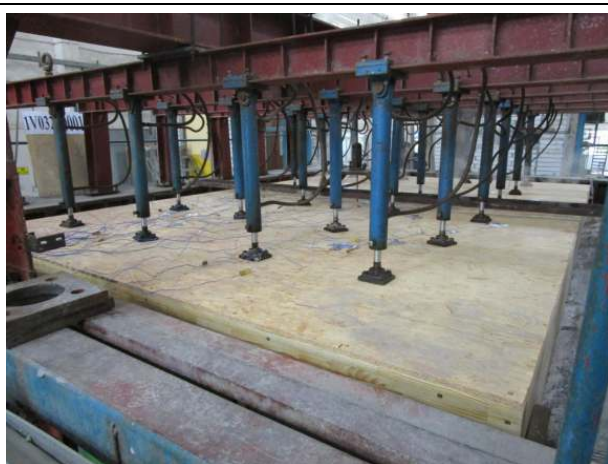
Photo 33: The unexposed surface of the specimen after test duration of 15 minutes.

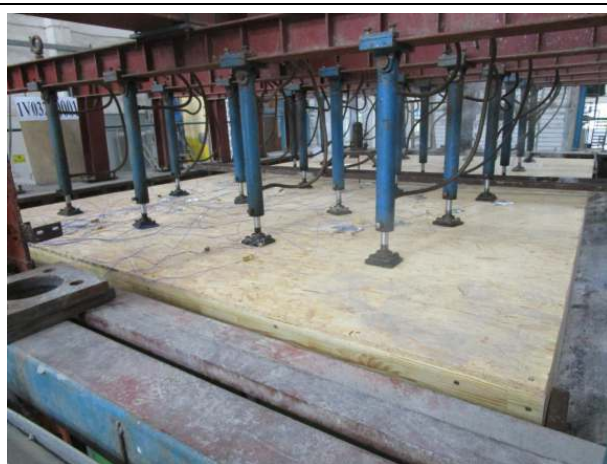
Photo 34: The unexposed surface of the specimen after test duration of 30 minutes.

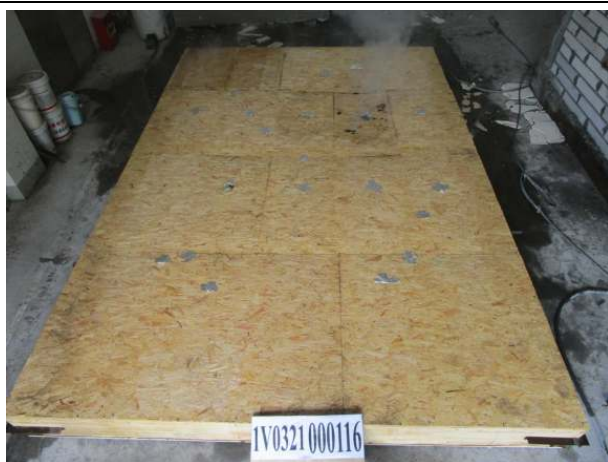
Photo 35: The unexposed surface of the specimen after the test.

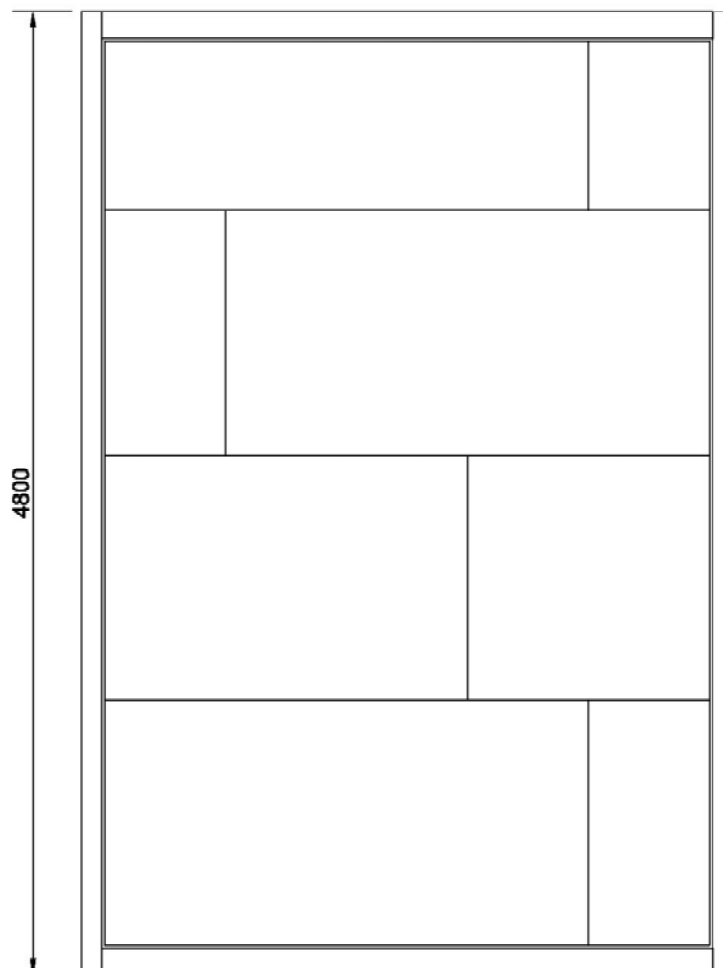
Figure 2 - Specimen Structural Drawing

Plasterboard Layout

<u>Item</u>	<u>Description</u>
1. Floor Joists	
Material	: I-Joist, 2 rectangular timber flanges and OSB web
Size	: 240mm Depth; Timber flanges: 47mmx47mm
Centres:	: 600 mm
2. Floorboards	
Material	: OSB Board
Thickness	: 1 layer, 18mm thick
Fixing method	: All board joints staggered with respect to adjacent layer and screw fixed to all joists
3. Ceiling boards	
Material	: Standard Gypsum Board
Thickness	: 1 layer, 15mm thick
Fixing method	: All board fixed to joists with Drywall screws at max.230mm c/c. The joints between the boards were filled with joint filler with was also used to cover the heads of the screws.
4. End Joists	
Material	: Glulam
Size	: 240mm high x 50mm thick
Fixing method	: Fitted across the ends of the joists and through screwed to each joist.

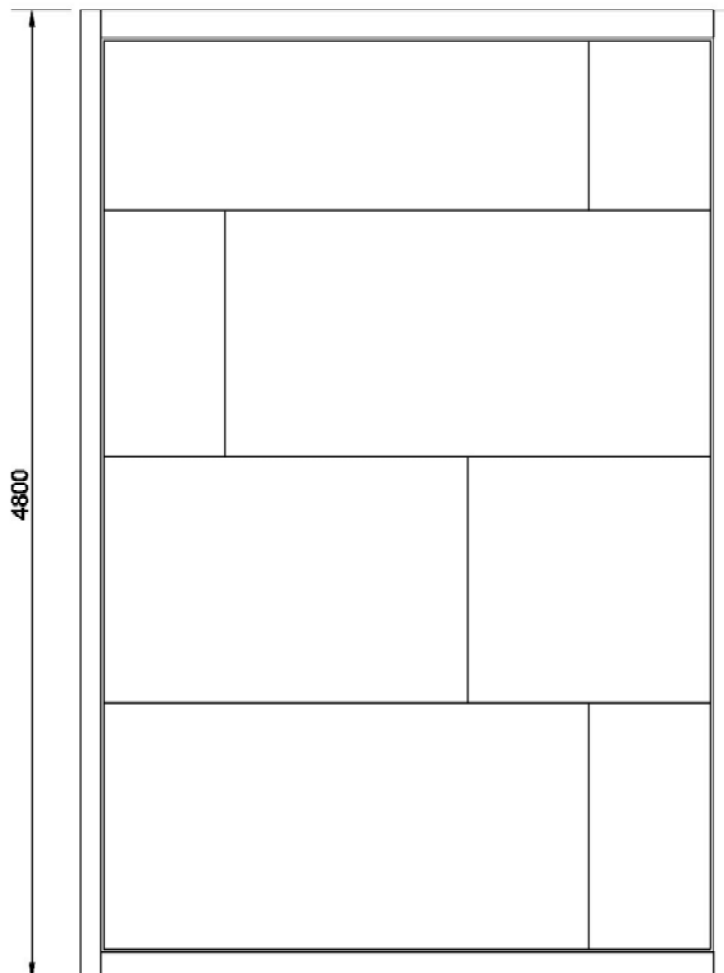
Figure 3 - Specimen Structural Drawing

Plasterboard Layout

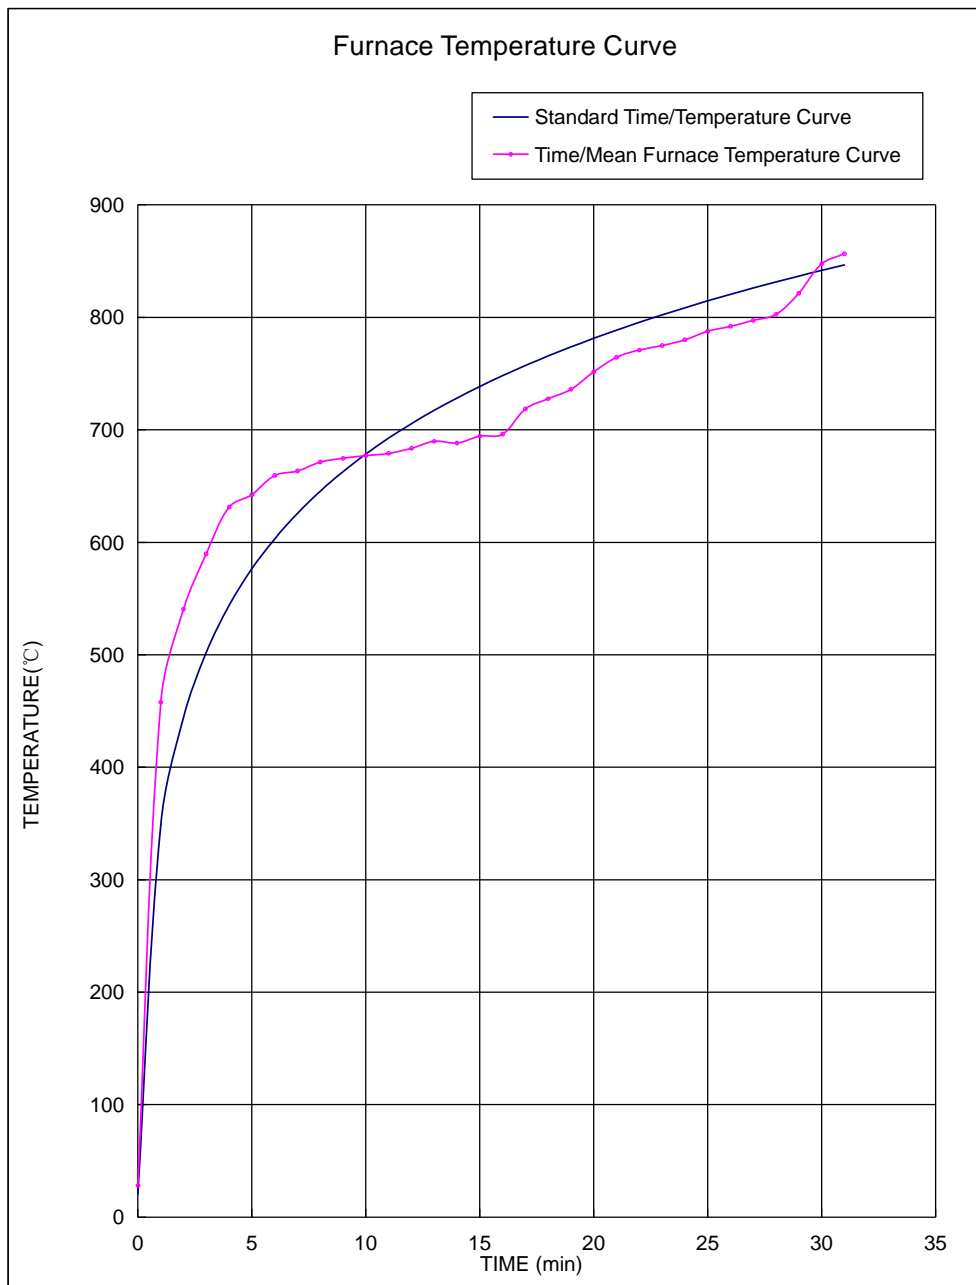
Figure 18 - Furnace Temperature Curve

The ambient temperature at the beginning of the test was 22 °C.

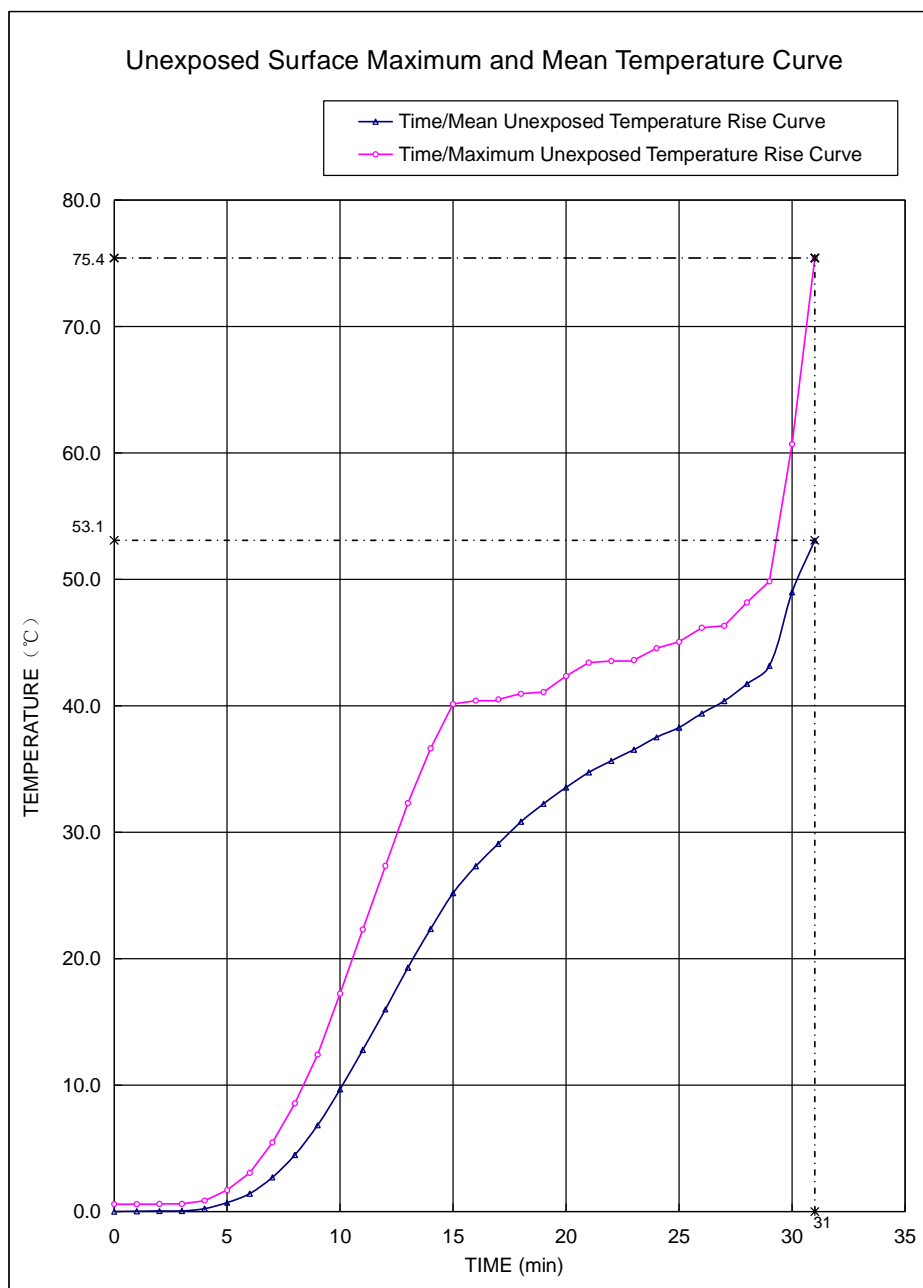
Figure 19 - Unexposed Face Mean and Maximum Temperature Curve

- a) When the mean unexposed face temperature increases by more than 140°C above its initial value;
- b) When the temperature recorded at any positions on the unexposed face is in excess of 180°C above the initial mean unexposed face temperature;
- c) When integrity failure occurs.

Insulation: 31 min (No failure)

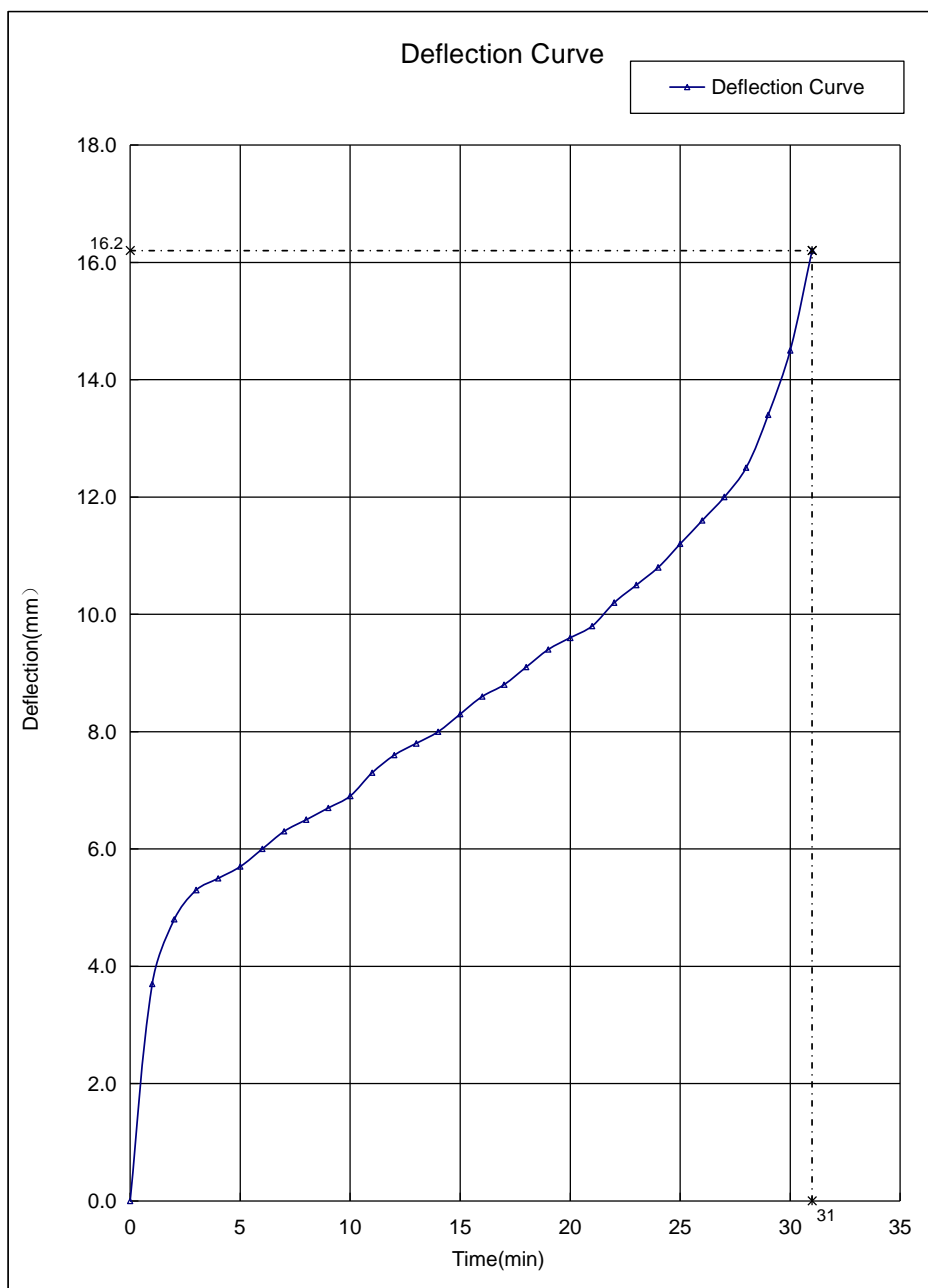
Figure 20 - Deflection Curve

Loadbearing capacity: A failure of the test construction to maintain its loadbearing capacity shall be deemed to have occurred when any of the requirements specified in given as follow are exceeded.

Loadbearing Capacity: 31 min (No failure)
